Manhole Inspection Summary

Manhole # S49AA_010MH

Insp Date: **5/8/08 9:24 AM**

Location Address: **543 n lakewood ave**

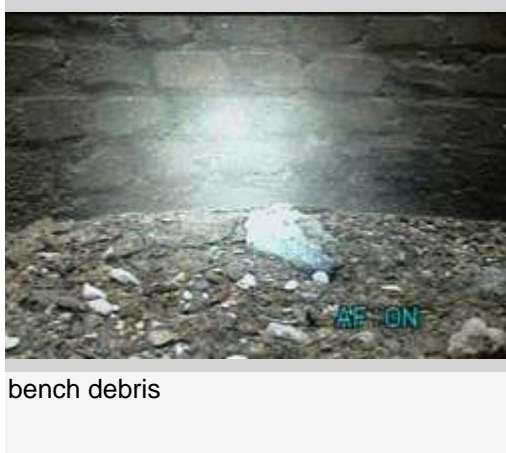
Defect 3

Condition: ☐ Sound ☐ Cracked ☐ Root Intrusion ☐ Deteriorated ☐ Leaks ☒ **Debris**

bench debris

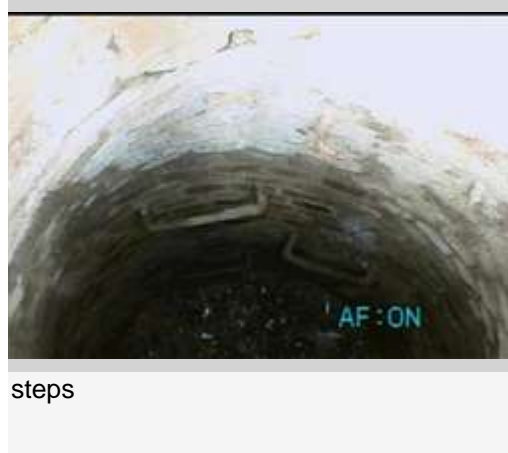
Defect 2

Count: **4** Missing: **1** ☒ **Corroded**

steps

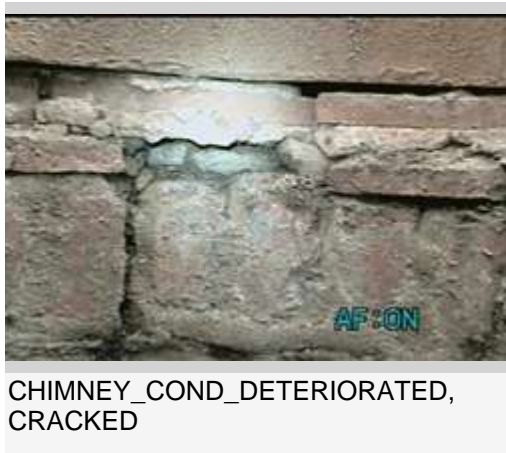
Defect 1

Condition: ☐ Sound ☒ **Cracked** ☐ Root Intrusion ☐ Loose Brick ☒ **Deteriorated**

CHIMNEY_COND_DETERIORATED,
CRACKED

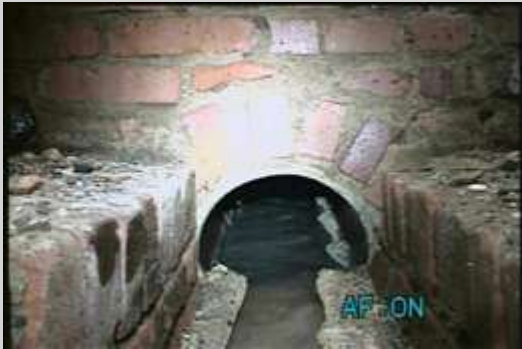
12 O'Clock Outflow

10 in. Circular Gravity Sewer
Pipe Out @ 12 O'Clock

Invert Depth: **9.41** (ft.) Flow Characteristics: **Fast**

Infiltration: **None** Pipe Seal Cond: **Unknown**

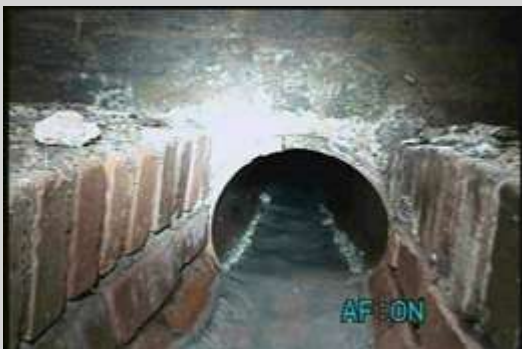
6 O'Clock Inflow

10 in. Circular Gravity Sewer
Pipe In @ 6 O'Clock

Invert Depth: **9.37** (ft.) Flow Characteristics: **Fast**

Infiltration: **None** Pipe Seal Cond: **Unknown**
